Milwaukee County Courthouse – Façade Evaluation

PROJECT: Milwaukee County Courthouse
Façade Evaluation
Milwaukee, Wisconsin

DATE: June 8, 2010
FILE NO: 301164

FACADE EVALUATION

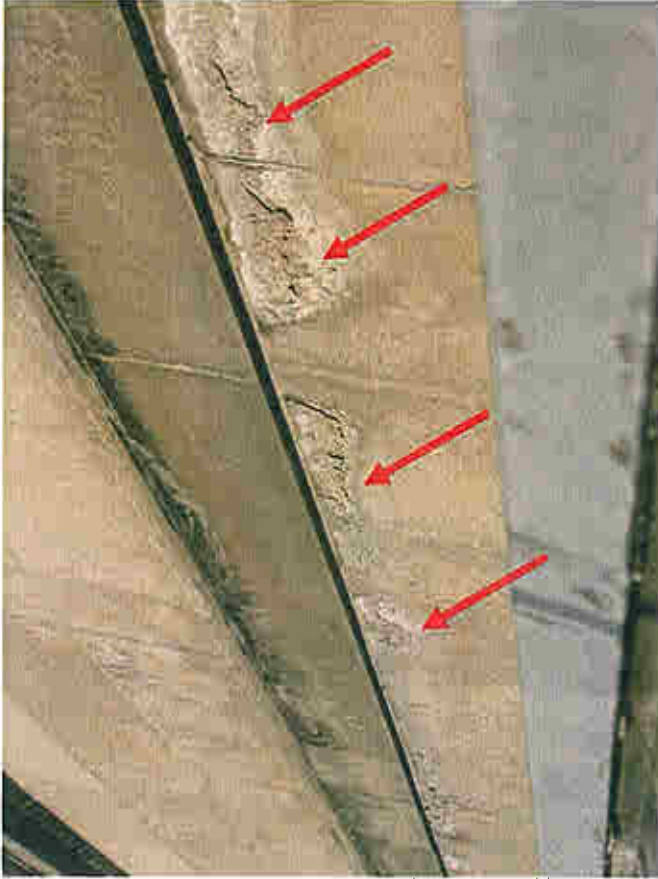
<u>Quantities</u>	
West Elevation	45 sq. ft.
South Elevation	50 sq. ft.
East Elevation	250 sq. ft.
North Elevation	15 sq. ft.
Total	360 sq. ft.

Photo #45 – Low severity spalls in limestone

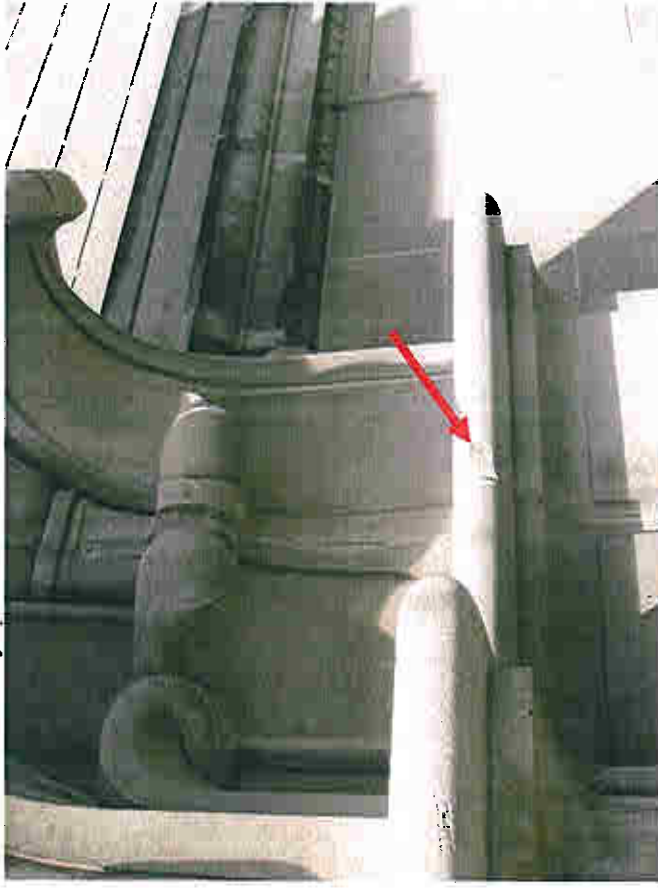
Photo #46 – Low severity spall in limestone

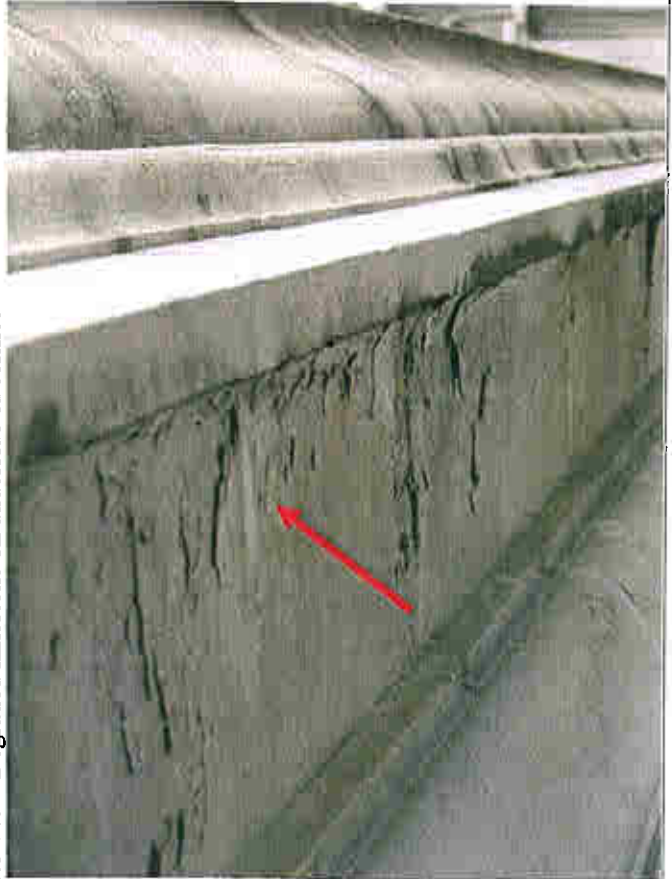
Photo #47 – Degraded limestone on underside of cornice

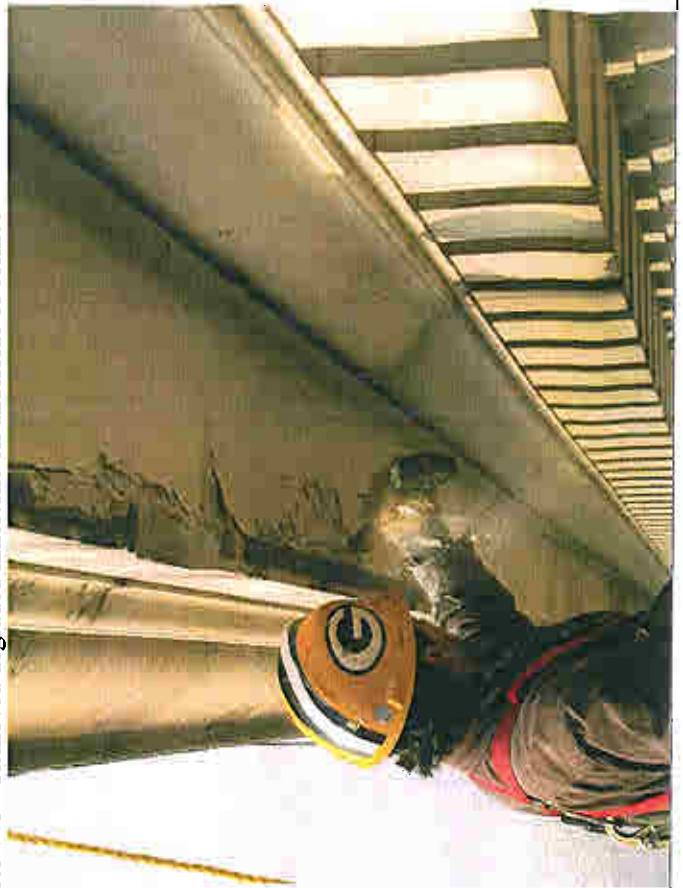
Photo #48 – Removed degraded limestone on underside of cornice

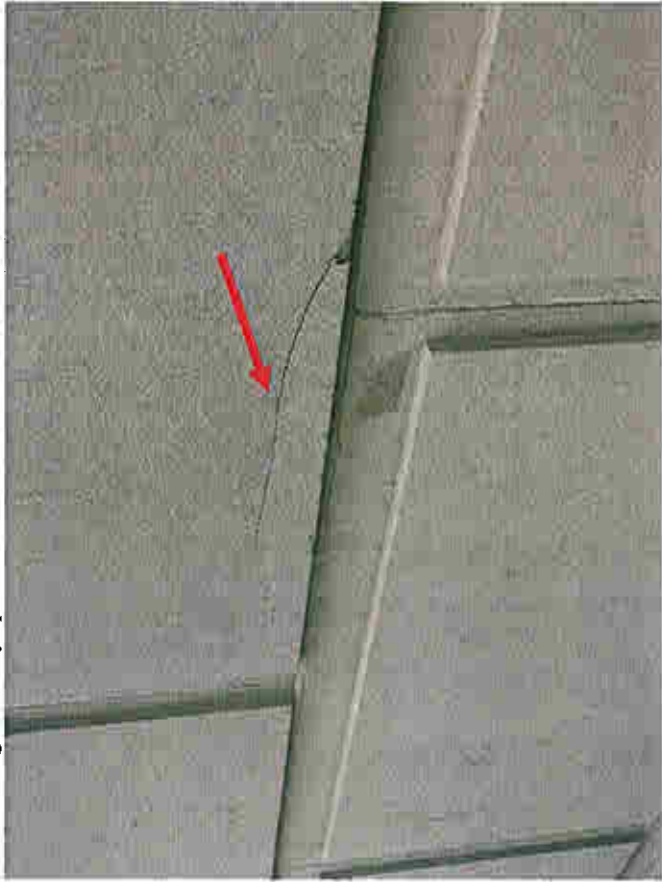
<u>Quantities</u>	
West Elevation	1 sq. ft.
South Elevation	1 sq. ft.
East Elevation	2 sq. ft.
North Elevation	14 sq. ft.
Total	18 sq. ft.

Photo #49 – High severity spall in limestone on north wall

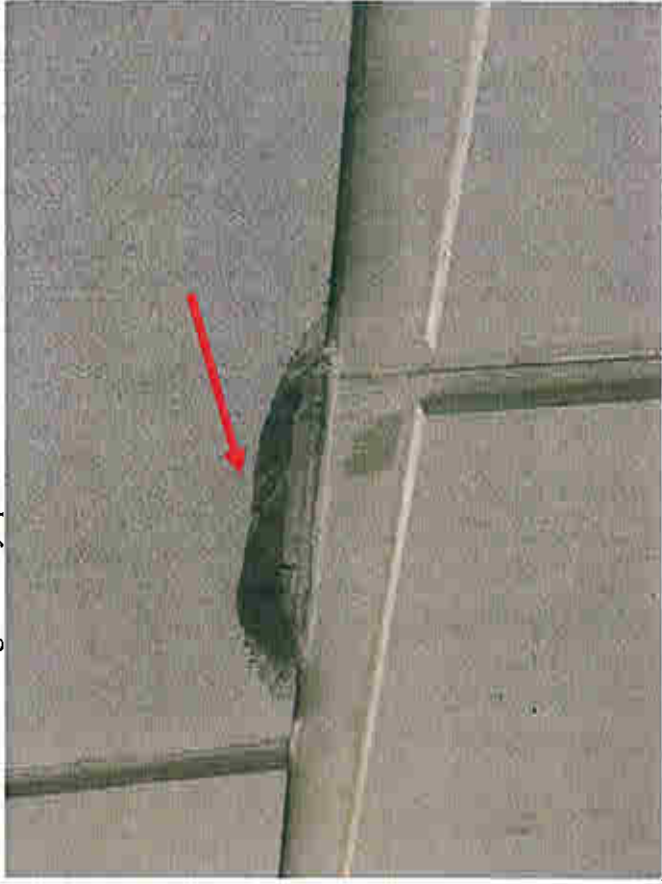
Photo #50 – Removed high severity spall in limestone on north wall

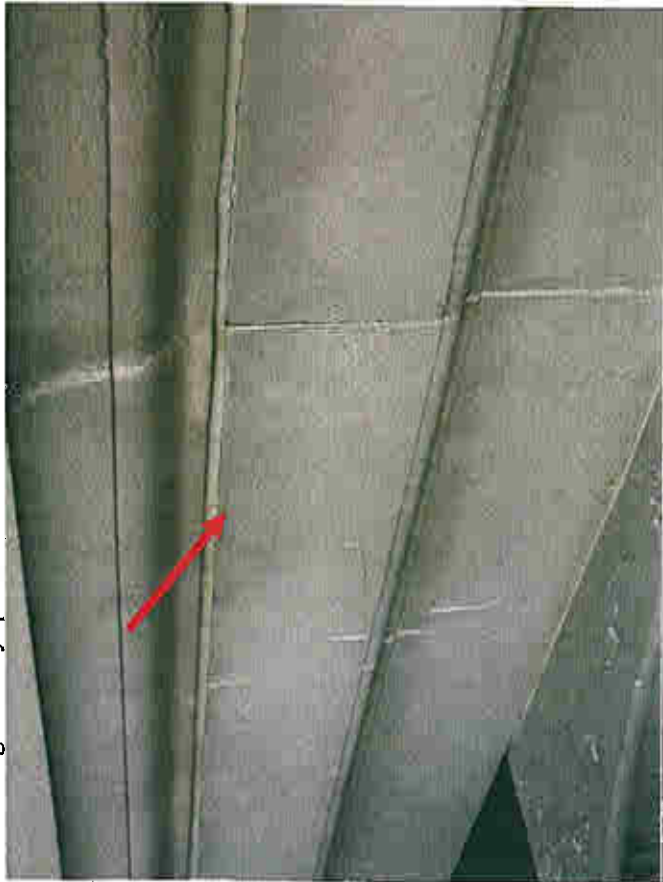
Photo #51 – High severity spall in limestone at north end of east wall

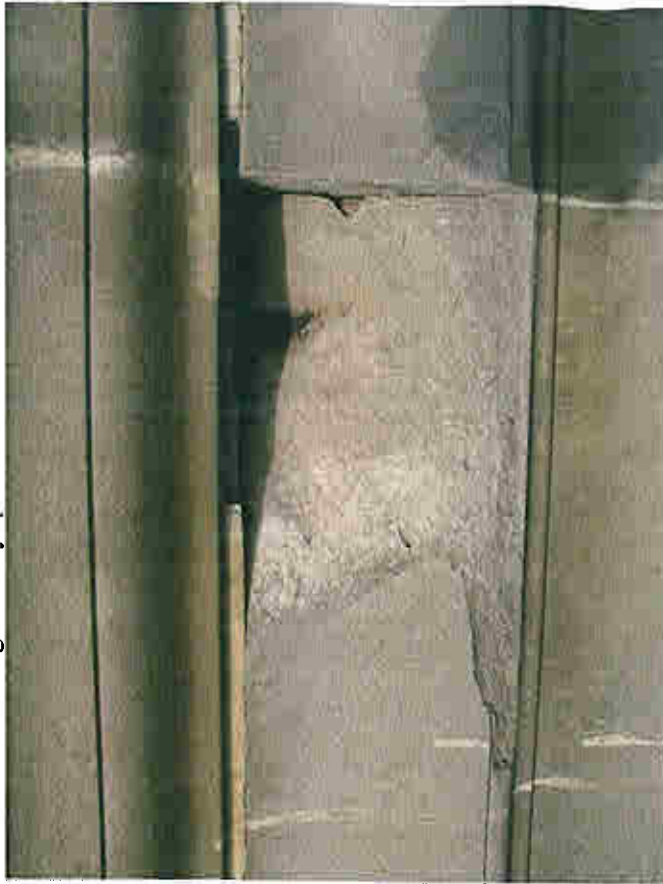
Photo #52 – Removed high severity spall at north end of east wall

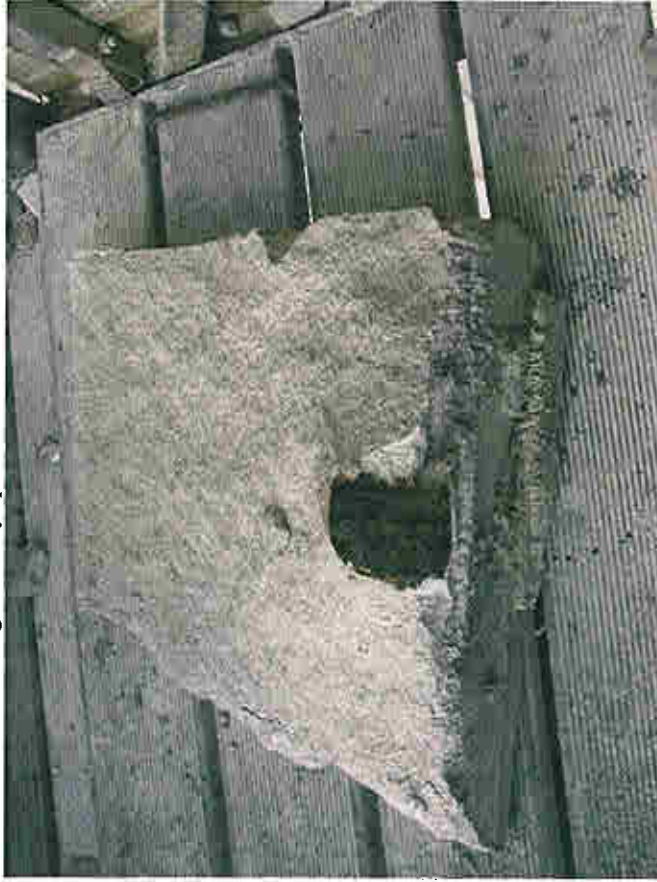
Photo #53 – Remains of high severity spall at north end of east wall

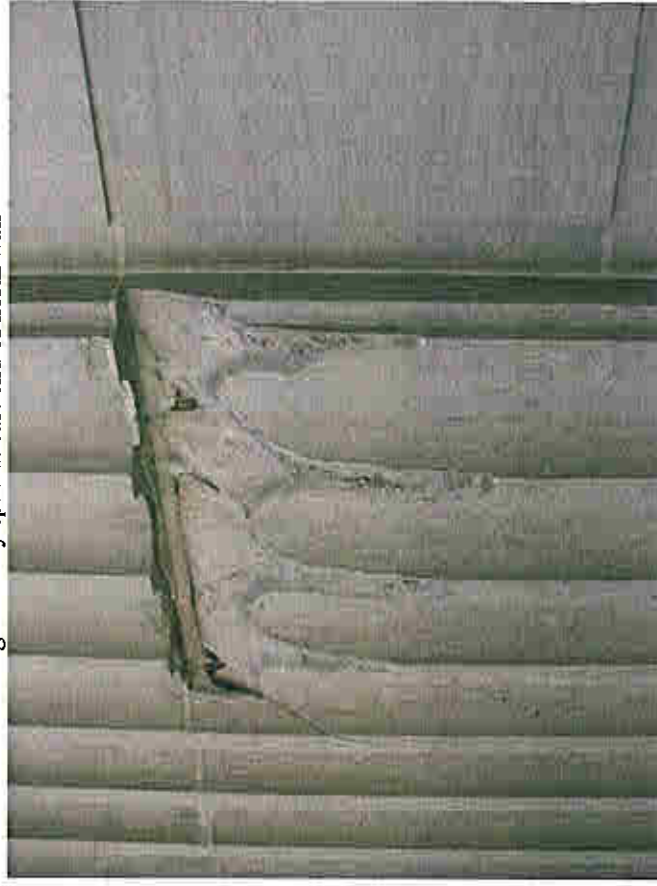
Photo #54 – Removed high severity spall at east end of north wall

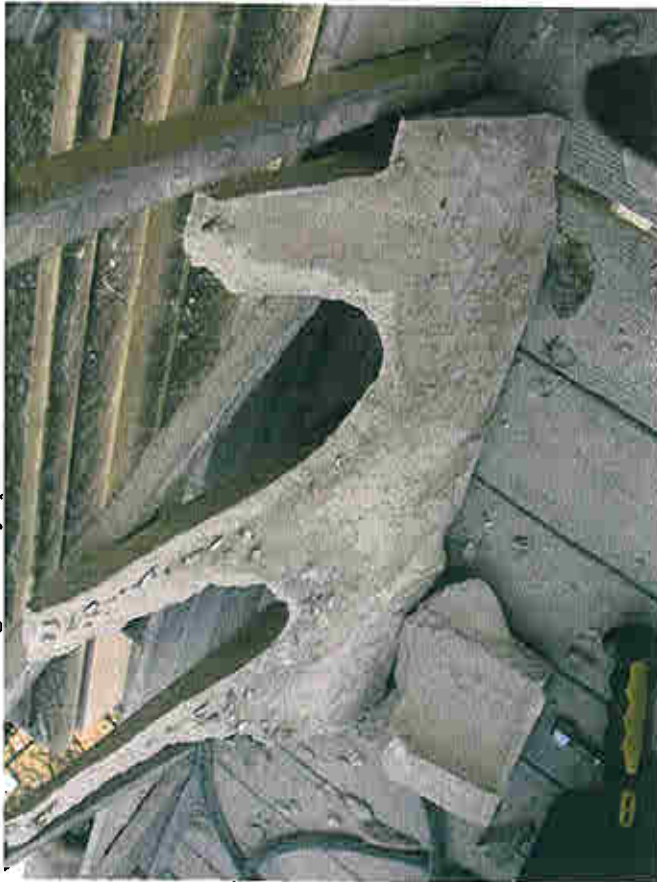
Photo #55 – Remains of high severity spall at east end of north wall

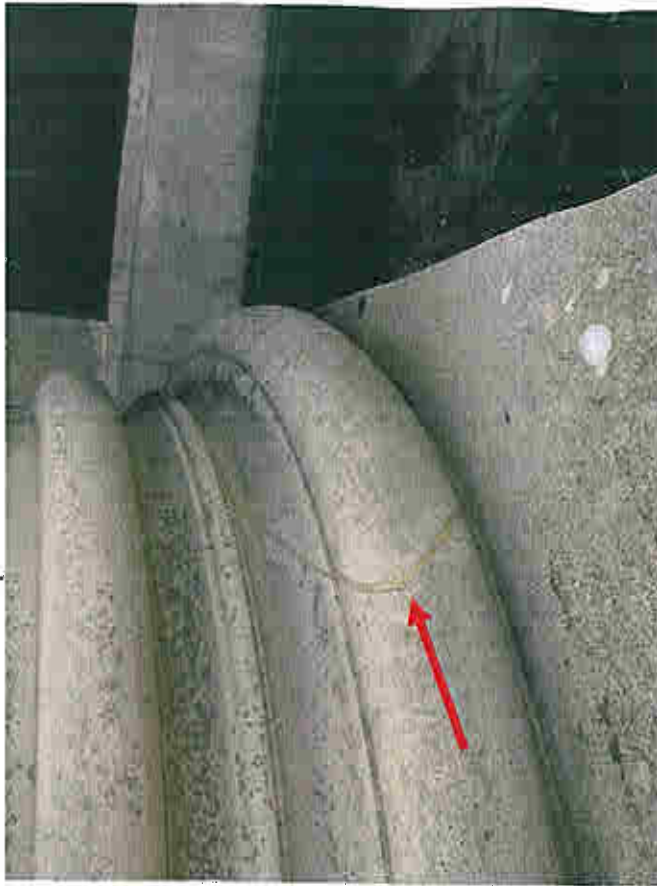
<u>Quantities</u>	
West Elevation	70 ln. ft.
South Elevation	35 ln. ft.
East Elevation	85 ln. ft.
North Elevation	70 ln. ft.
Total	260 ln. ft.

Photo - #56 – Previous crack repair at base of column

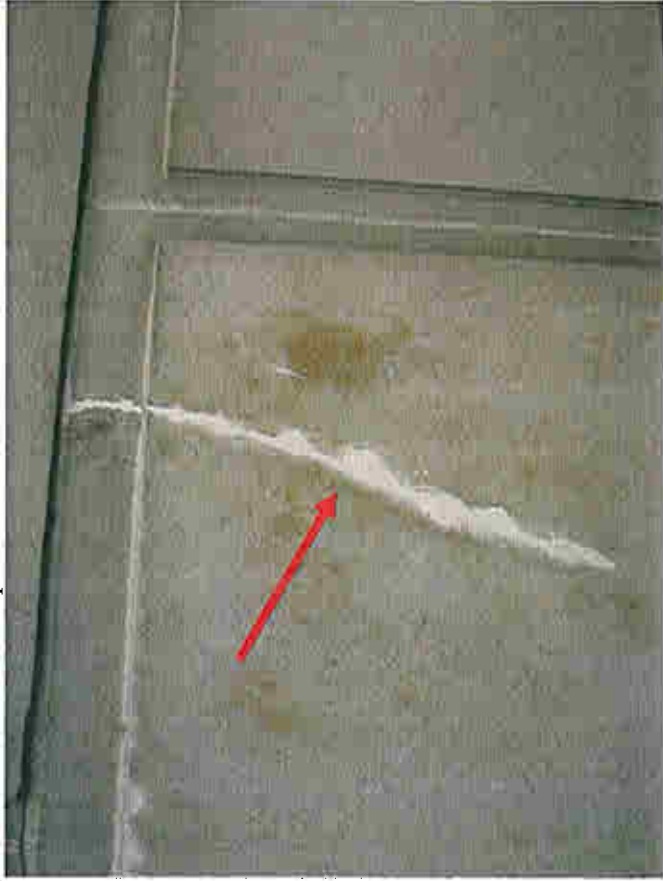
Photo #57 – Previous crack repair

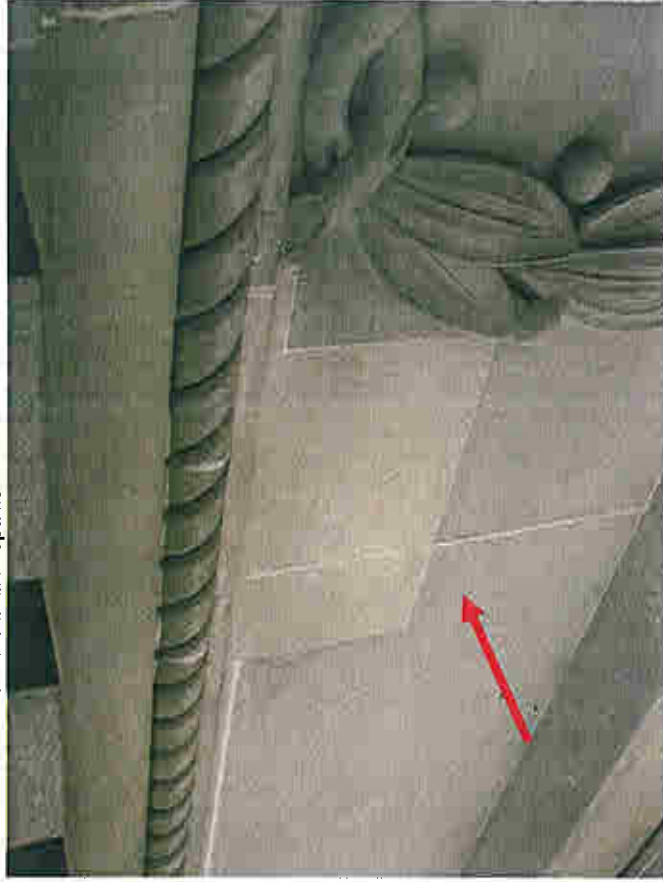
<u>Quantities</u>	
West Elevation	2 sq. ft.
South Elevation	2 sq. ft.
East Elevation	2 sq. ft.
North Elevation	14 sq. ft.
Total	20 sq. ft.

Photo #58 – Previous Dutchman repairs

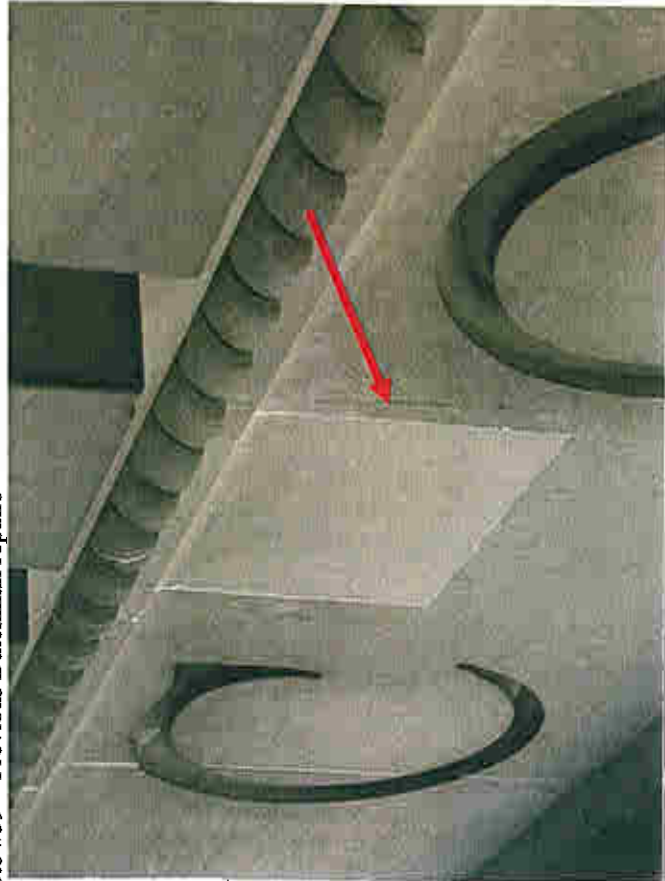
Photo #59 – Previous Dutchman repairs

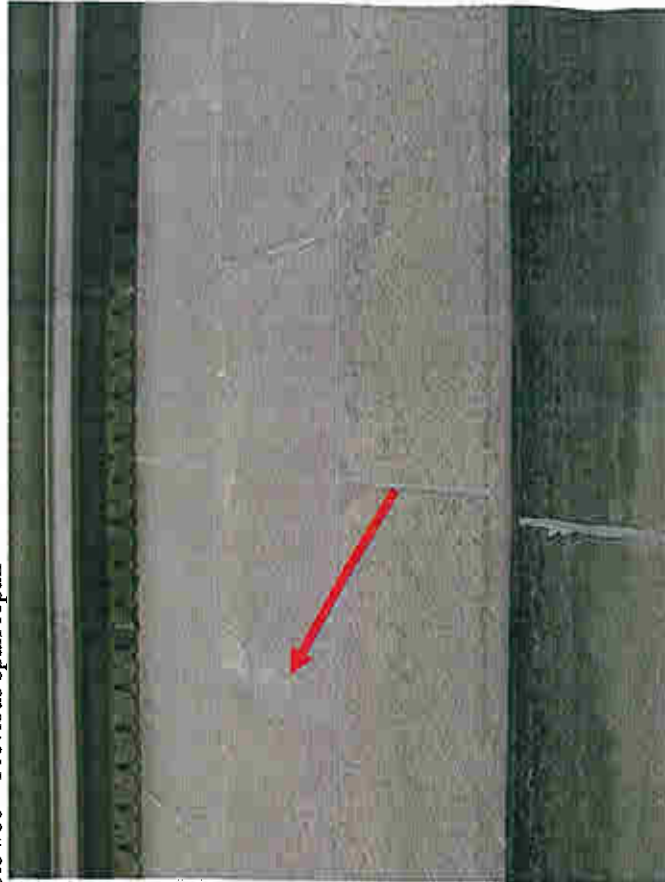
<u>Quantities</u>	
West Elevation	15 sq. ft.
South Elevation	15 sq. ft.
East Elevation	40 sq. ft.
North Elevation	5 sq. ft.
Total	75 sq. ft.

Photo #60 – Previous spall repair

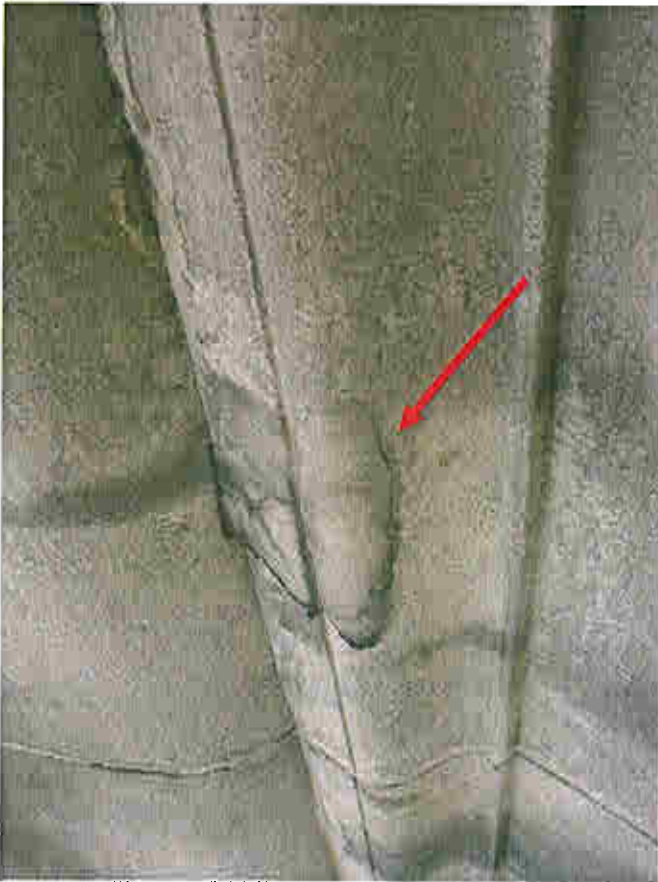
Photo #61 – Previous spall repair

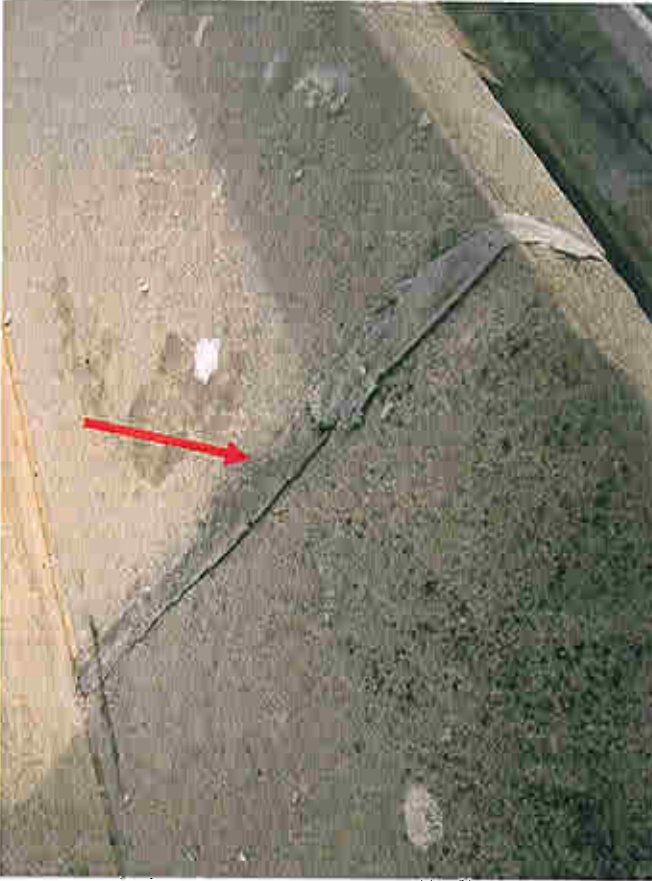
<u>Quantities</u>	
West Elevation	100% at ledges
South Elevation	100% at ledges
East Elevation	100% at ledges
North Elevation	100% at ledges

Photo #62 – Failed joint sealant on top of ledge

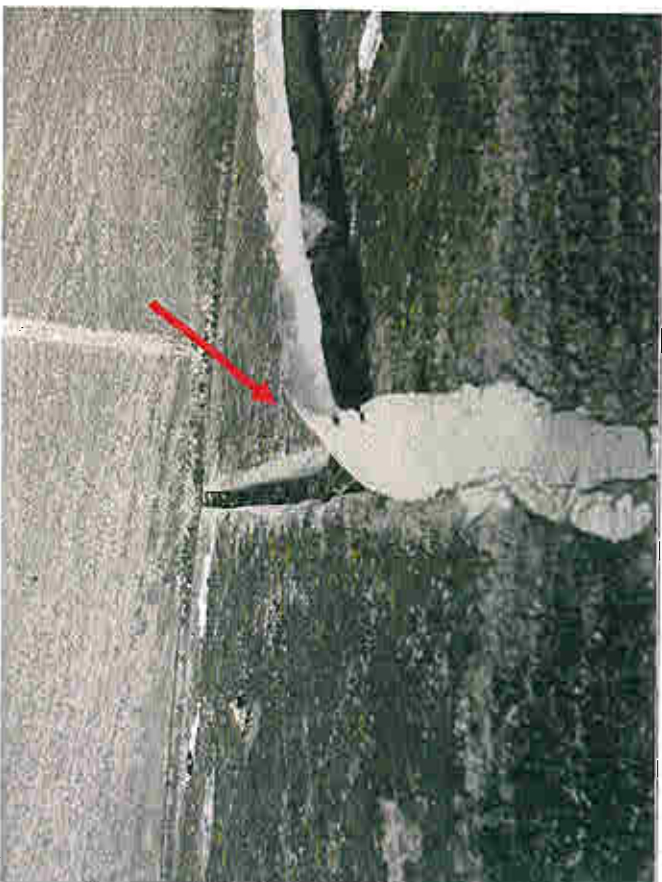
Photo #63 – Failed joint sealant on top of ledge

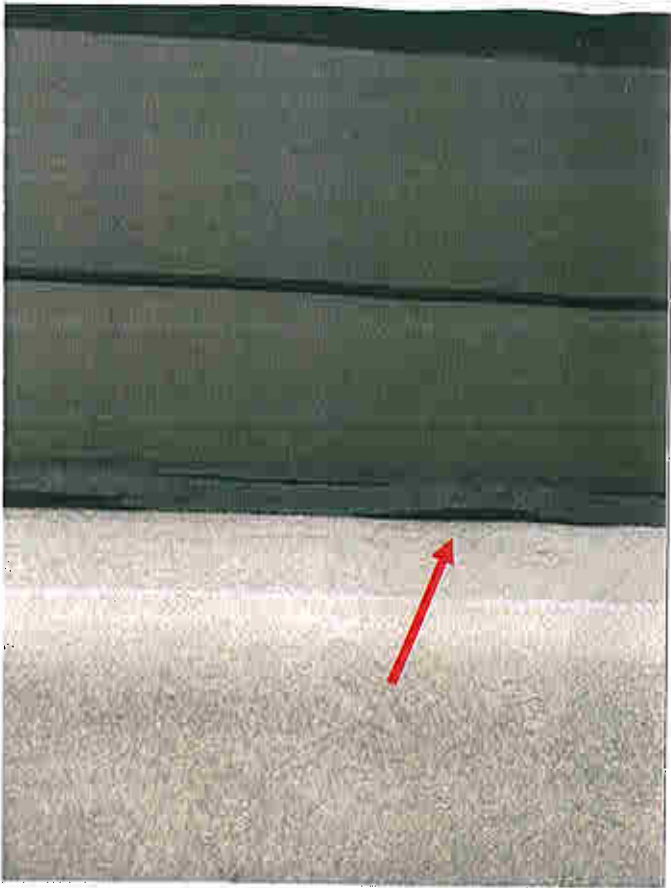
<u>Quantities</u>	
West Elevation	100%
South Elevation	100%
East Elevation	100%
North Elevation	100%

Photo #64 – Failed window sealant

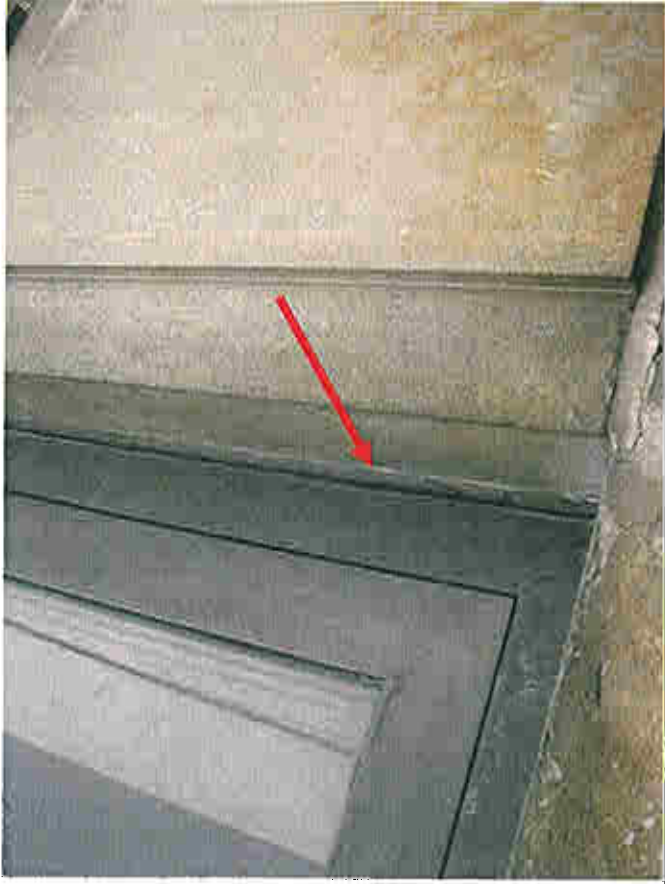
Photo #65 – Failed window sealant

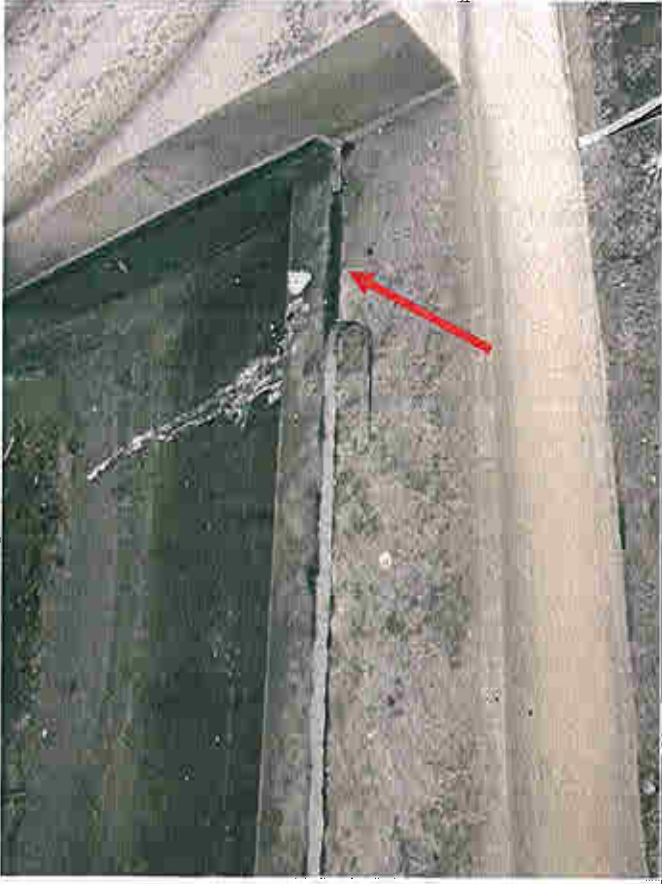
<u>Quantities</u>	
West Elevation	100%
South Elevation	100%
East Elevation	100%
North Elevation	100%

Photo #66 – Failed sealant around perimeter of drain well

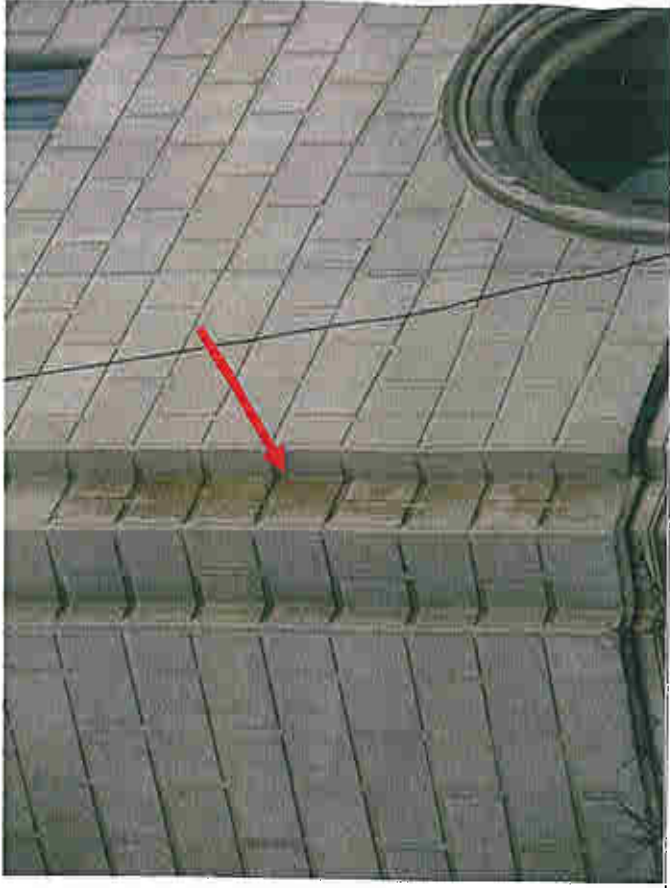
<u>Quantities</u>	
West Elevation	
South Elevation	10 sq. ft.
East Elevation	400 sq. ft.
North Elevation	
Total	410 sq. ft.

Photo #68 – Rust stains at southeast corner

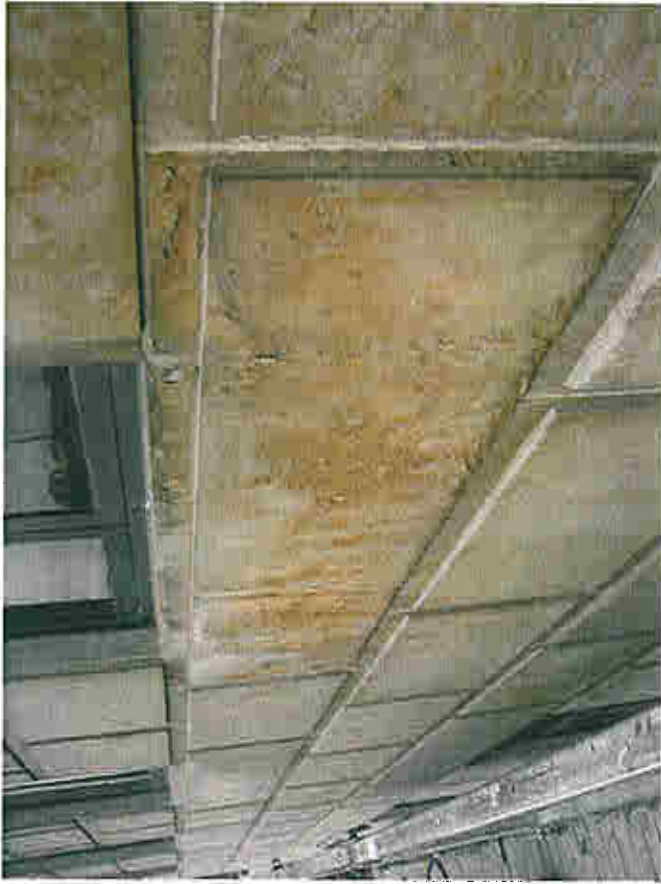
Photo #69 – Rust stains on face of limestone

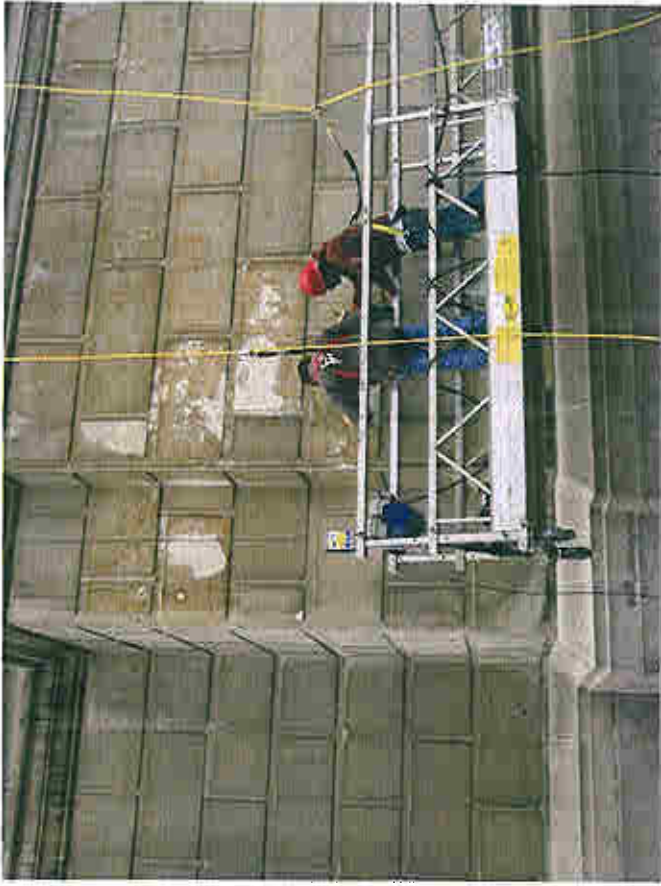
Photo #70 – Removed deteriorated limestone at rust stain locations

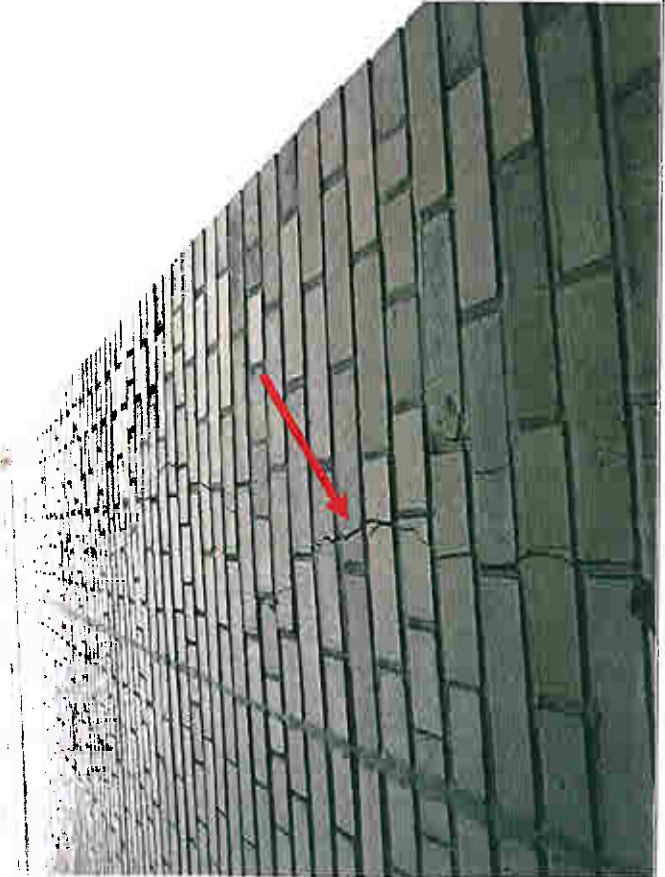
<u>Quantities</u>	
Above roof	100 bricks

Photo #71 – Cracks in brick wall above low roof

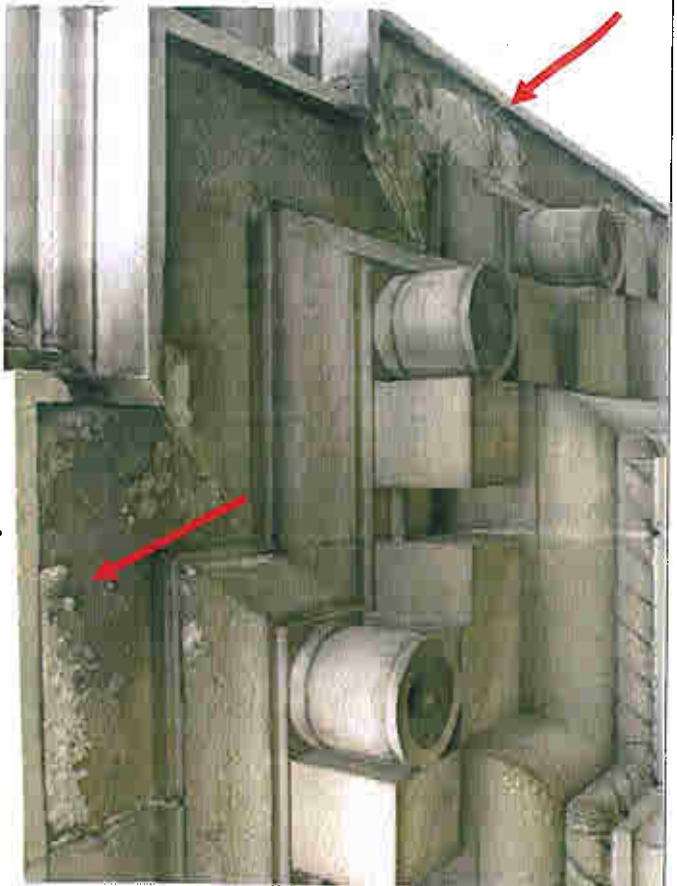
On April 30, 2010, a 197' crane with a basket provided access to the cornice level of the southeast corner and adjacent east side of the building. Portions of loose limestone at the corner which were noted during a previous swing stage drop, but were unable to be reached at that time, were removed (Photos #72 - #73).

Photo #72 – Removed loose masonry at southeast cornice

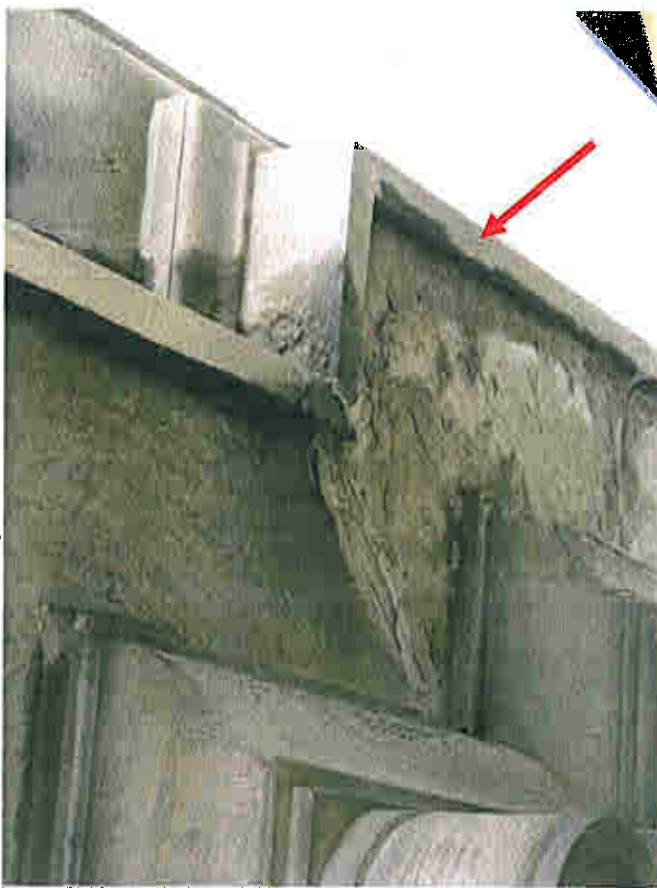
Photo #73 – Removed loose masonry at southeast cornice

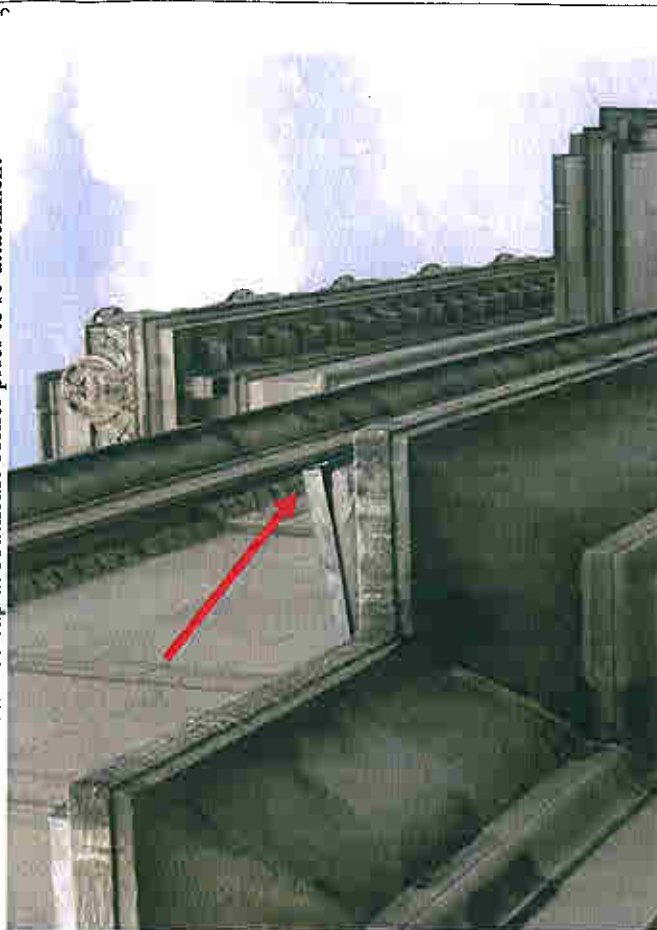
Photo #74 – Detached cornice cap at southeast corner prior to re-attachment
